# CROSS

## Confidential Reporting on Structural Safety

### Newsletter No 6, April 2007

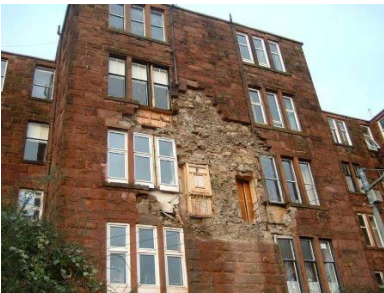
Fears have been raised over the future of some of urban Scotland's sandstone tenements after severe weather caused part of a wall to collapse in Glasgow.

The collapse of a rear wall in one of Glasgow's most prestigious tenement areas led to nine families being evacuated. Although the wall is said to have been suspect for some time the collapse followed high rainfall levels and raised fears that other properties could be at risk. One warning to other tenement-dwellers came from the Scottish Stone Liaison Group. Another came from a property expert who said: "There could be real problems ahead. The weather has been exceptional, with high winds accompanying unprecedented rain levels."

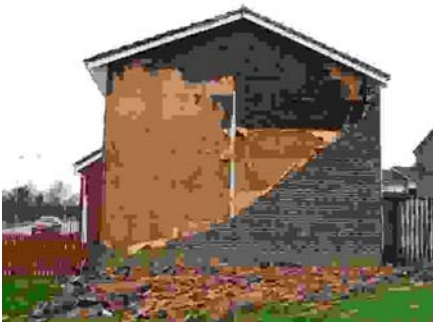
Following request for examples of wind damage this collapse was reported of the external brick skin of gable wall of a two storey timber frame terraced house.

*Comment It appears that the ties have either failed or pulled away from the timber frame behind. During recent periods of strong winds there were many press reports of damage to domestic dwellings constructed in more traditional ways. See News Items. (Report 078)*
