Confidential Reporting on Structural Safety

Newsletter No 8, October 2007

COLLAPSE OF BRICKWORK CLADDING

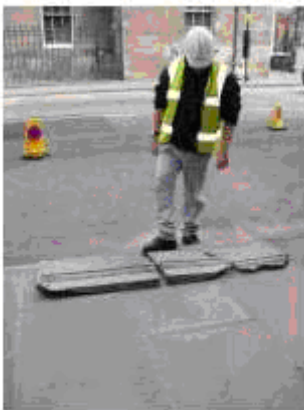
Fallen masonry from SCOTCROSS

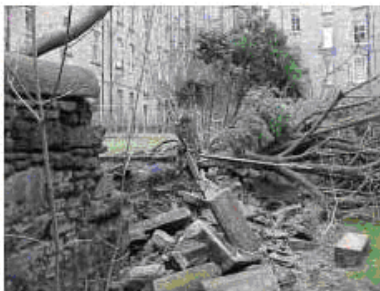
Collapsed freestanding wall from SCOTCROSS

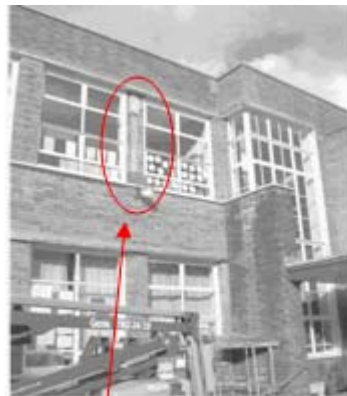
The external leaf of a brickwork pier at first floor level fell down onto the playground of a school adjacent to the main entrance door. Fortunately there were no casualties. The reporter believes that the structure is a concrete encased steel frame. Bricks on end had been used on either side of a column between windows to form a cavity and an external skin built without provision for tying back to the main frame. The school was closed for an initial period of a week whilst investigations were carried out on the rest of the elevation. The brickwork cladding was removed and replaced with an alternative material. The reporter's firm has advised the local authority in case there are other schools of similar construction in the same ownership.

Column from which brickwork fell

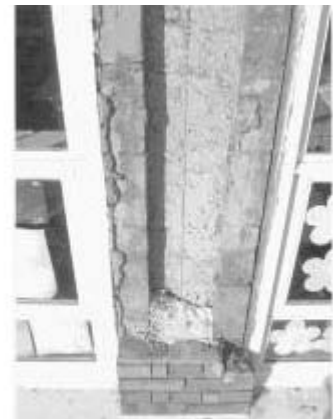
Concrete casing with no ties to brickwork cladding

CROSS comments: As with many other reports of masonry falls from buildings it is fortunate that there was nobody underneath at the time of collapse. The SCOTCROSS project which gathered data over a two year period up to August 2007 had 1,200 reports of material falling, or in danger of falling, from old buildings. In 12 cases passers by were injured. A full report on the project will be published in due course by the Scottish Building Standards Agency. There is a risk to people from falls such as the one given above and they are usually due to combinations of poor construction, poor maintenance, and weathering. Two examples are shown below. The most significant failures are those where there is a pattern and hence further falls can be expected if nothing is done. The Scottish investigation may be extended to other parts of the UK but meanwhile CROSS welcomes reports of falling, or dangerous and about to fall, materials. So far as new construction is concerned this is perhaps a timely reminder that good

building practice requires the ability to see how all items are restrained and retained within buildings, and that construction industry professionals should be proficient at good detailing. It is also a reminder to school authorities and school governors of the importance of regular condition surveys to detect defects before they become dangerous. (Report 078)
