Newsletter No 9, January 2008

Reports in this Issue

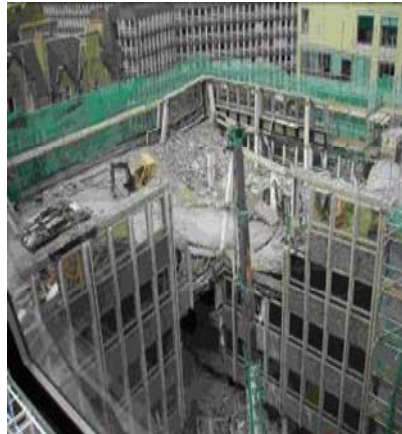
Another report is of an incident that occurred recently in a UK city when a floor suffered a structural collapse during the demolition of a reinforced concrete building. Three small excavators fell down at least one floor and one of the site personnel was injured and three others were rescued. The cause has still to be ascertained.

The collapsed floor

CROSS comments: *The comments made above apply here also. However, it is not known in this instance whether the collapse was due to a shortfall in the design, or in the manner of demolition adopted. It can be seen from the picture that one column protrudes through the floor slab which may indicate shear failure around the column head. Both reports reinforce the fact, which is backed by HSE statistics, that demolition risks are amongst the highest in construction activities. A review of proposed demolition procedures by a structural engineer should always be carried out. Notice should also be given to the local authority whenever demolition is planned. (Report 090)*

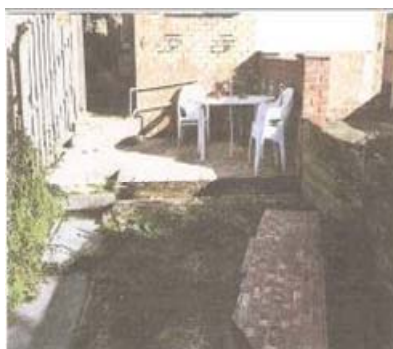
A reporter wants to raise important structural points about free standing walls especially those that are planned and built by untrained people. He says that in the back garden of a house stood a 100 mm brick wall, built of Flettons in cement mortar, about 2.5m long, and just under 1.0m high. There was a patio behind it about 200mm high, and in front of it grass. It was therefore nominally retaining some ground, certainly enough for it to have plenty of water going into the bottom two or three courses. It had no restraint, neither by a cross wall at either end, nor were there any piers. It was some years old. Examination of photographs (the wall has disappeared) indicates that there was a certain amount of damp at the base and it seems likely to the reporter that there would have been minor thermal and moisture movements here, and possibly freeze/thaw effects, which caused the lowest exposed mortar course just above the grass to loose its bond.

Late one evening, says the reporter, three young people returned home. Two sat on chairs on the patio, a young lady perched herself on the wall. It rocked, she fell backwards, and the wall came down as a single piece of brickwork weighing the best part of half a tonne, on top of her. Apart from bruising and laceration, her neck was broken in two places. Amazingly, and according to the medical experts as a result of outstandingly good emergency treatment coupled with outstanding long term care, she has only limited disablement.

Collapse that caused serious injury (report 094 above)

The problem is how to recognise existing walls that are unstable and potentially dangerous. Keeping a careful eye on suspect walls for cracks is important as these could be the early signs of the wall distress. Walls should obviously be vertical and not out of plumb. Walls that have not been constructed with appropriate materials may show long term damage from frost and rain penetration. If there is material piled on one side of a wall this can be dangerous as can tree roots and nearby excavations. Boundary walls often act as partial retaining walls and even with small differences in level trapped water can build up and lead to problems. This is not an exhaustive list and other factors may have to be considered. So far as children are concerned they should be discouraged from climbing on garden walls as this can initiate collapse resulting in serious injury or death. If there is doubt about the condition of a wall a structural check should be made. If a wall is manifestly dangerous the local authority should be advised as they have powers to remove such structures if there are imminent dangers. (Reports 094, 059)

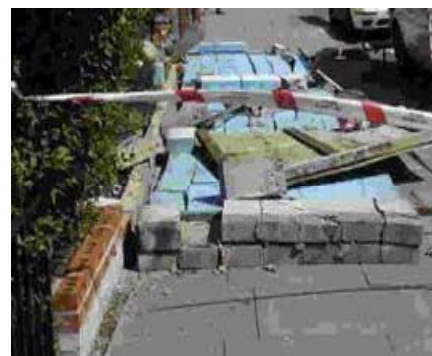
Collapse that caused death of a child (report 059 below)

A report was received from a local authority about a boundary wall to the front garden of a domestic property that collapsed suddenly resulting in the death of a child who was passing. The 1.7m high wall was constructed from a single leaf of 100mm thick hollow concrete blocks. The wall was subject to lateral pressure from an immediately adjacent tree and building materials stored at the rear of the wall.

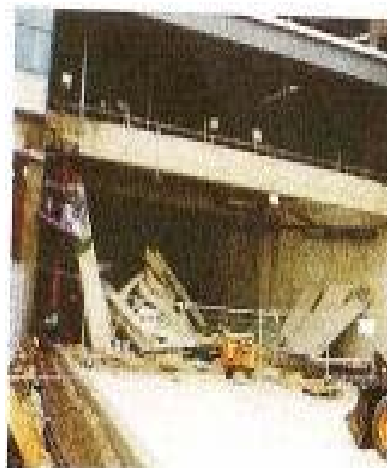
Half joints in concrete structures have been used successfully over many years notably in bridges and buildings, says a reporter. They can offer great advantage in terms of construction and design although their performance depends on good design and detailing and maintenance. Failures in half joints can happen if reinforcement is not detailed properly. Recently the reporter's firm has come across a half joint in some precast beams with a very poor reinforcement detail. The beams were erected as planned. However due to one of the defective joints failing, a collapse was initiated which caused the subsequent collapse of a series of beams and precast slabs as shown in the photograph. The investigation revealed that the position of the steel dowels (for shear) and reinforcement in the beams was incorrect and not sufficient to withstand even dead loads.

CROSS comments: *Half joints can be satisfactory in buildings but are not now recommended in external situations where they may be subject to weathering. The Highways Agency says that half joints in bridges pose a risk as due to difficulties of access they cannot be maintained properly. This is in addition to risks that may exist from design or construction defects. In many cases in buildings the thickness of the nib will be small so that the position of the reinforcement is not ideal. Joints should, so far as is possible, be positioned so that they can be inspected and then maintained if necessary. (Report 088)*
