CROSS

Confidential Reporting on Structural Safety

Newsletter No 10, April 2008

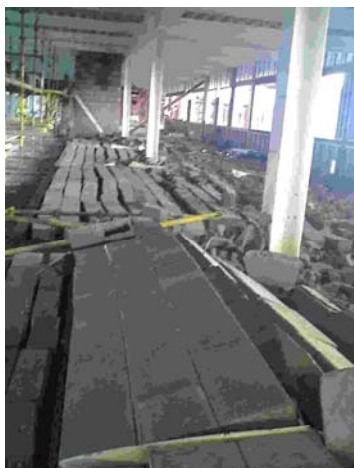
An internal corridor wall collapsed in a school under construction. The wall, when checked, was not to be unstable in all stages of its construction even when built up to the head, until the external envelope was substantially complete. Programme constraints indicated that the walls would always be built before the envelope. A generic assessment of risk by the designer did identify propping masonry in the temporary condition, but, says the reporter, this was not clearly enough set out for the contractor to spot, though he should have questioned it. There were a number of panels which were subject to temporary situations which were more onerous than the permanent conditions, but the one that fell was off-grid and had no intermediate supports being 37m long by 3.8m high. It was indeed fortunate that the site had finished for the day and no-one was injured.

CROSS comments: *It is common for internal walls to be subject to temporary wind loads that exceed those in the final condition. For the significant scale of the walls here, it would have been essential for the temporary stability issues to have been identified prior to construction, in order to minimize the risk of collapse. Designers must eliminate hazards and reduce residual risks in a manner that contractors understand. They must highlight potential risks where temporary load cases are more onerous than the permanent case. They must also identify special cases where extra care is needed, and it might be thought that a wall of these dimensions was one of these on the basis of general building knowledge as well as of regulation. Contractors also should be more aware of temporary situations and assess each trade package as it develops. A review of temporary works should be carried out on any project to identify any short, or long term, supports that may be necessary, backed up by engineering advice as necessary. There is also the issue that programme changes may have been made without the knowledge of the designer who should always remain involved. Regulation 28 of 'Construction Design & Management Regulations 2007' covers stability of "temporary structures" and "temporary states of weakness or instability" and applies to such situations. (Report No 099)*
