CROSS

Confidential Reporting on Structural Safety

Newsletter No 11, July 2008

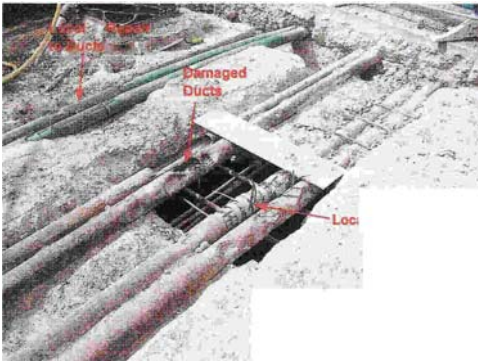
A culvert, which carries a river under a busy main road, has an internal span of 2.4m and headroom of 1.0m. The reinforced concrete roof slab was 300mm deep and had, from the time of its construction, four 120mm metal service ducts cast into it. Some years later two additional ducts were cut into a channel on the top of the slab. There had been a regime of inspections and key dates are:

- 1989 inspection satisfactory
- 1995 inspection found some damage due to the installation of new cable ducts which was repaired
- 2001 inspection generally satisfactory
- 2007 inspection found that a section of the roof had partially collapsed

Whilst demolishing the slab it became apparent that the only reinforcement was the longitudinally spanning tension bars. There was no transverse reinforcement and no reinforcement on the top of the slab. The bars were unevenly spaced, particularly where they had been grouped together so as to not clash with the original ducts. The presence of the newer ducts evidently impacted adversely upon the performance of the slab. The probable cause of the failure of the slab was that at some time the slab had cracked but as this was not visible it was not repaired. Over time and under loading, the cracks opened up allowing ingress of water causing corrosion to the reinforcement.

- The inspection regime was helpful in that problems were identified in 1995 and 2007 which allowed repairs to take place before a critical collapse in which a vehicle could have fallen into the culvert causing danger to both people and property.
- The damage on both occasions was only seen by an internal inspection of the structure, thus suggesting that inspections should always be as complete as possible.
- Damage can be done to a structure and not display itself, or affect a structure's serviceability for a substantial period of time.
- Any structure which is known to have been damaged must be monitored closely thereafter.
- The roof slab did not have a red-sand asphalt carpet over its top surface. If it had this might have alerted contractors that they were working over a structure and prevented damage to it.

CROSS comments: *The reporter mentions a red sand carpet but the most commonly used product is now a proprietary sprayed on protection system. What is also concerning is that the Utilities should have been issuing NRSWA notices to the Highway Authority. They should have then identified that the route included a structure and classified it as an Engineering Difficulty requiring additional caution and (sometimes) submission of method statements to the Highway Authority for approval. The extent of surveys is not always clear and here there are several points worth highlighting: good records must be kept, the relevance of defects must be understood, and the ownership of, and responsibility for, structural modifications must be clear. Those making alterations or repairs must be made aware of the potential structural consequences of their actions. It is important that access is available for inspection purposes. Utility companies should make their own inspections and assessments of aging infrastructure elements before disturbing them. (Report No 097)*

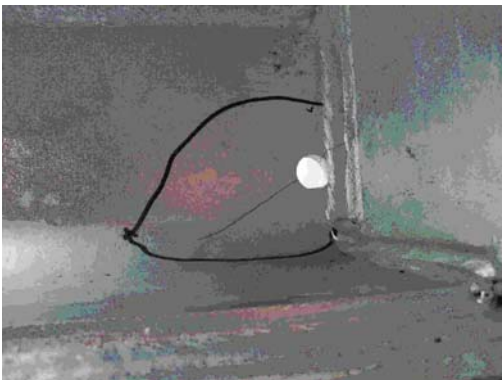
A major contractor reported an incident that had occurred in which a threaded eyebolt failed during an operation to lift a section of stonework into place. Although there were no injuries this was clearly a high potential incident. Investigation has revealed that the eyebolt was not marked with its Safe Working Load (SWL). Eyebolts are accessories for lifting under the Lifting Operations and Lifting Equipment Regulations 1998 (LOLER) and must be marked with their SWL. The eye had failed at a poor quality weld where it had been bent back on itself to form the loop of the eye. It had then opened out and fractured at the opposite end, releasing the load. The contractor's staff have been instructed to:

- ensure that all eyebolts are marked with their SWL
- ensure that the selection of any lifting accessory, including eyebolts, forms part of the lifting plan and must be undertaken by someone competent to select lifting equipment ie the appointed person/lifting co-coordinator or other suitably qualified engineer.

CROSS comments: *Lifting equipment used in conformity with LOLER should not exhibit this kind of problem so the use of un-rated components in a lifting rig must be avoided, as must the use of modified components. When possible lifting frames should be used under the control of a qualified rigger who would check the SWL before beginning operations. It may however be difficult to ascertain the weight of the component being lifted although this should be given by the manufacturer. The example illustrates the importance of knowing the source of material and equipment supplied. (Report 110)*
