Confidential Reporting on Structural Safety

Newsletter No 12, October 2008

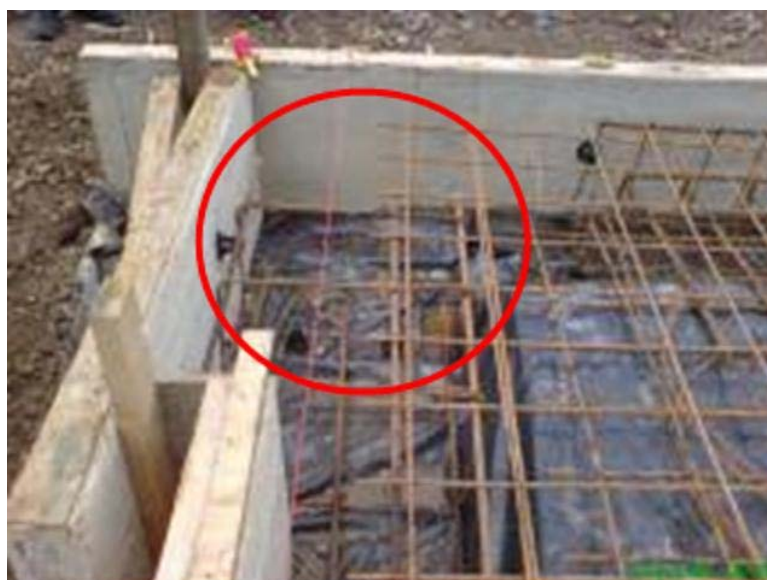
The photograph below is of ground beams for a multi-storey development where the subcontractors carrying out the ground works failed to provide sufficient continuity reinforcement. In an attempt to provide continuity the steelwork was repositioned with the result that all reinforcement from a corner of the building was removed as shown in the highlighted region of the photograph. The local authority building control officer twice advised the subcontractors that this was unsatisfactory but they claimed that the consulting engineer had considered the work acceptable. Regardless of this statement the work was not approved.

Missing reinforcement

The reporter advises that this is not an isolated case because on many sites there is little or no involvement of the design engineer to ensure that his details are being followed on site. Traditional checks on construction standards from Clerk of works and site resident engineers are now rare because Clerk of works are not generally employed and the site engineers knowledge usually relates to setting out only. A reputable design team and main contractor were carrying out this development but the lack of basic knowledge of the ground workers would have gone unchecked if it had not been for the local authority inspection. There is, considers the reporter, a concern about the lack of site involvement by design engineers in respect of critical areas of construction. Reliance is placed on sub contractors but their lack of knowledge creates risk of fundamental errors in the construction process.

CROSS comments: *Unless adequate supervision is provided on site, problems will eventually result. This separation of design from construction is a potentially dangerous trend. It is common practice in the UK for reinforcement to be detailed by the contractor. In such a situation the design engineer would check that the reinforcement placement drawings met the design intent. It would appear that no such placement drawings were approved or if they were the steel fixing details were not followed. Whilst the*

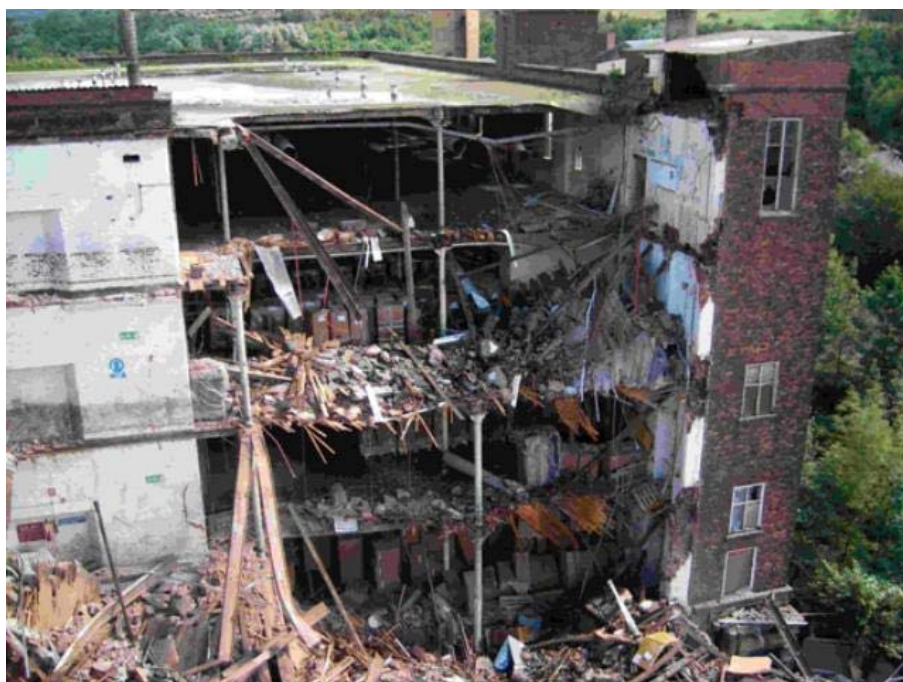
Nearby families were evacuated after part of a four-storey former mill building collapsed adjacent to their homes. Residents reported hearing a sound like a heavy goods train as the building fell. The mill was used for storage and was about to be converted into residential apartments. The reporter said that the construction was typical of 19th century mills with brickwork interior walls, cast iron columns and filler joist floors. It is thought that the sudden collapse was initiated by the failure of one of the columns.

CROSS comments: *This is a classic example of progressive collapse following the removal of a single element. It happened suddenly and apparently without warning and it was fortunate that nobody was inside and the debris did not hit the nearby houses. See below for more general comments on such buildings. (Report 121)*

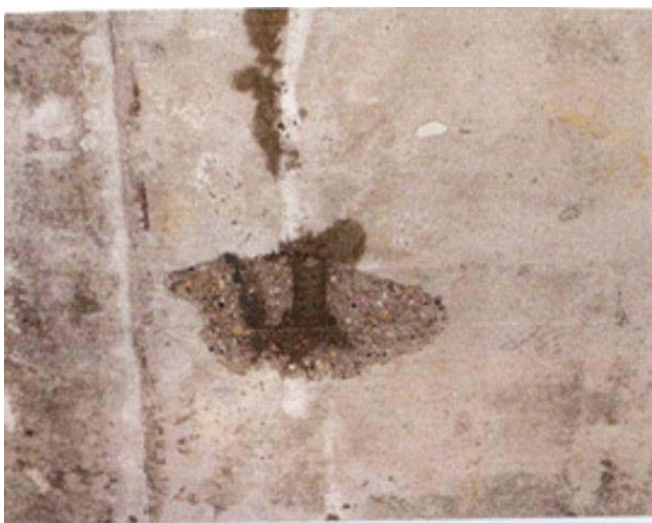
Pre-stressing in concrete has been used in bridges and heavy civil structures for many years and more recently in buildings. A reporter has come across a situation where during grouting of the ducts in a slab, patches of concrete as big as 0.5m x 1m and 30mm thick fell on to the ground creating a safety hazard. Investigation showed that the main reasons for falling patches of concrete were combinations of the following:

- 1) During grout the pressure was not monitored at the delivery end and entry end into the duct and higher pressures than normal were used.
- 2) The grout was expanding very quickly - more than that which was specified.
- 3) The ambient temperature was low during grouting.
- 4) Water found its way into the lowest points of the duct during rain and eventually froze resulting in partial ice expansion.

Soffit of slab showing pre-stressing duct

CROSS comments: Grouting of pre-stressing ducts requires careful workmanship and supervision. Recent investigations have revealed the likelihood of a lack of properly grouted ducts in some buildings. One method of minimising the risks is to ensure that post tensioning installation is only carried out by properly trained teams, for example those certified for PT installation through the UK CARES certification Scheme. It should be noted that point 4 above (water ingress and freezing) can occur in completed structures where grouting has not been properly executed. An excellent guide on procedures and techniques is given in the CARES note distributed in June 2008 and now put on their web site: (www.ukcares.co.uk/PDF/CARES_Post-Tension%20Leaflet.pdf). Reference is made to the need for project specific reviews and advice is given for new structures. (Report 089)
