# CROSS

## Confidential Reporting on Structural Safety

### Newsletter No 15, July 2009

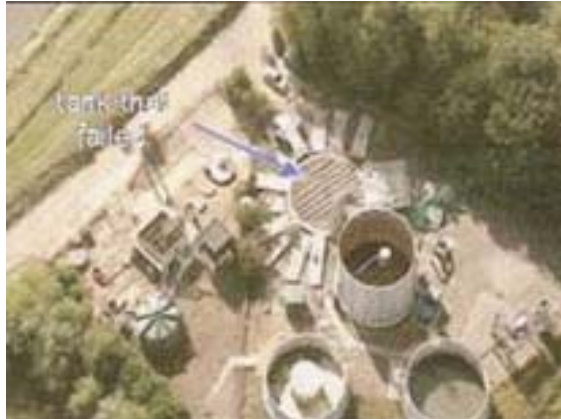
A utility company suffered a sudden and catastrophic failure of a concrete tank at a sewage treatment works. The tank was constructed from pre-cast concrete panels which were pre-stressed with circumferential un-bonded cables in grease filled sheaths. They have a large number of similar tanks. A photograph taken after the

collapse shows the concrete panels lying around the base in a star formation. All parties who have investigated this incident agree that the ultimate failure was caused by stress corrosion cracking, but it is not possible to say exactly what caused it. At some stage there was pressure water testing of the cable ducts which may have had an effect on subsequent performance. The design appears to rely on the grease and the sheathing to provide its corrosion protection, and it would not be expected that grease used for this purpose would emulsify in water. Tanks of this nature, which are built either above ground or partly buried, rely entirely on the tendons for their structural integrity. The utility company who own the facility therefore recommend erring on the side of caution and do not recommend the use of such tanks unless a system of protecting the cables from corrosion is in place and the possible influence of the grease is clarified.

**CROSS comments:** Failures with unresolved causes are difficult to give advice on and this warning by the utility company should be taken seriously by owners, designers, and suppliers of such tanks. Of particular concern are failures which may be generic but not display signs of distress before collapse. CROSS would be very interested in hearing of similar concerns. (Report 147)

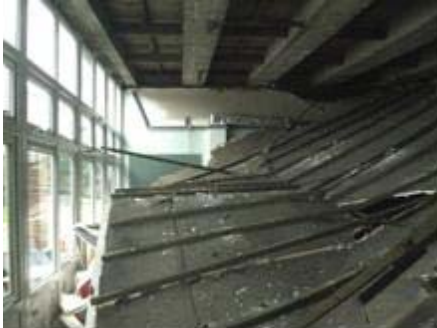
Ceiling and heaters after collapse

A new suspended ceiling incorporating radiant panel heaters had been installed at an existing school a few years ago. The flat-roof above consisted of a timber boarded deck supported on pre-cast concrete beams at approximately 1m centres. It was constructed 30-40 years ago. The original ceiling was of plasterboard fixed to timber battens spanning perpendicular to the concrete beams at approximately 0.6m centres. These battens were secured to the underside of the concrete beams with oval wire nails nailed into timber fillets cast into the soffit of the beams. The new ceiling and heaters were all supported by a system of hangers all fixed through the original ceiling and into the battens which carried the original ceiling. The plasterboard forming the original ceiling had been left in place. The combined weight of the new ceiling, heating panels and original ceiling was too much for the nails (acting in tension) fixing the timber battens to the soffit of the RC beams. Five years after installation the new ceiling suddenly collapsed, pulling the original ceiling and battens with it. The collapse affected virtually the full extent of one classroom. Fortunately it happened during the school holidays and no one was injured. The new ceiling had been specified by an Architect without reference to a Structural Engineer. No details of how the new ceiling should be supported were supplied and all responsibility for the fixings of the new ceiling and heating system was passed to the Contractor. It is not known whether the Contractor was aware of the form of the existing roof construction or whether he thought that he was fixing into the underside of traditional roof joists.

**CROSS comments:** Schools have the subject of several previous reports including an earlier ceiling collapse and here again it appears that the importance of a fixing system has not been appreciated. If this had been constructed under present legislation the architect would have failed to comply with duties under CDM in that the hazards associated with detailing such a structure without structural engineering input, or adequate supervision, were not adequately dealt with. (Report 130)

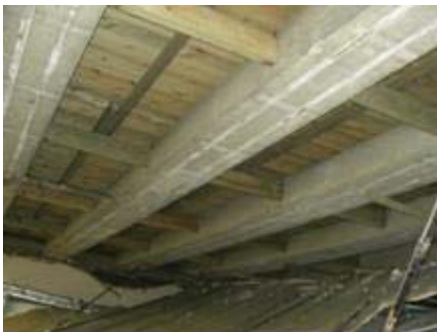
Concrete beams above
