Newsletter No 13, January 2009

Reports in this Issue

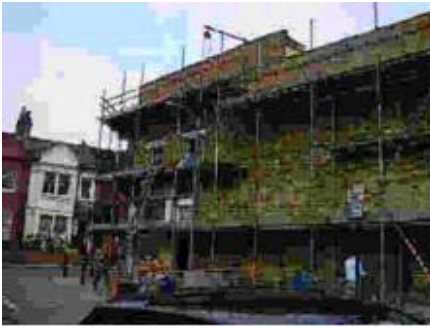
Before

The building was a two storey corner (end of terrace) property fronting a very busy, narrow major route in an area which is normally busy with pedestrians and traffic. On the ground floor there was a shop and there was residential accommodation above. Work had been in progress, without Planning or Building Regulations approval, for about a month to create a basement and loft conversion. A Building Control Surveyor visited the property and advised the builder to stop work until the permissions had been resolved. However, work continued.

Internal cross walls had been removed and chimney breasts had been removed from the party wall. It appeared that the internal area was gutted and the floors were supported on new steel beams spanning parallel to the front from party wall to flank wall. The robustness of the structure had been seriously compromised as there was virtually no lateral stability system. The external walls had been underpinned, rather poorly, onto largely non-cohesive soil, and at the time of failure a mini digger was excavating for the basement. It is suspected that the digger undermined the toe of the underpinning.

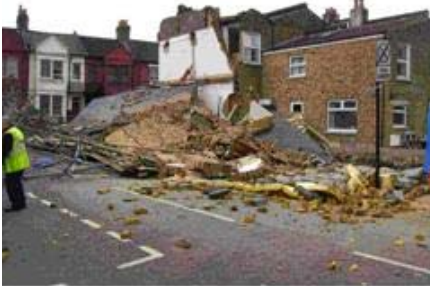
After

As a consequence the underpinning began to kick inwards and the pavement adjacent to the flank wall started to collapse. Police and Fire Brigade services were summoned and immediately called in Building Control. The building control engineer who was summoned to the scene was concerned about stability, but was unable to establish the extent of the work without entering the building. He decided that it was not safe to do so. Within minutes the building collapsed into the basement and scaffolding was thrown across the streets. There were no injuries.

CROSS comments: *The lesson to be learned is that this alteration work showed a total lack of understanding of the first principles of building stability and of the way that stability can be compromised by alterations and inadequate phasing of the work. Planning Permission and Building Regulations approval are an essential pre-requisite to carrying out alterations. The involvement of a structural engineer or building surveyor would have prevented this needless destruction. The skill and ability of the building control engineer called to the scene is to be admired. (Report 123)*

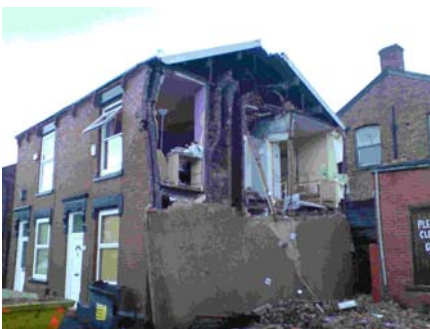
Collapse after failure to underpin

This is a case of collapse caused by a builder carrying out underpinning works. The property is a semi detached house which at sometime had been part of a larger terrace. It had only recently been bought by a first time buyer who noticed a problem with the gable wall and a structural engineer was commissioned to investigate. The recommendation was that a new external leaf should be constructed off a new foundation including underpinning of the existing wall in short sections. The report also described works to be carried out before underpinning and these included a requirement to tie the existing wall into the main house. The engineer gave advice to the owner on selection of a suitably qualified contractor and also offered to supervise. Unfortunately the owner decided to engage a builder on the recommendation of a friend. The builder ignored the engineer's report in respect of preliminary works and sequencing of excavations. Instead a trench was excavated the full length of the gable and left overnight without any temporary support. During the early hours the wall collapsed and the photo shows the condition of the wall when the Building Control Officer attended. The occupiers, including a baby asleep in the cot in the rear bedroom, were lucky not to be injured and were rescued by the Fire Service. To make matters worse the builder is uninsured and the owner's insurers will not accept liability.

CROSS comments: *This is a tragedy for the owner who unwittingly appointed an incompetent builder after starting on the correct path by engaging a structural engineer. All alteration work should be carried out by competent builders who carry appropriate insurance - but how is an owner to*
