Confidential Reporting on Structural Safety

Newsletter No 3, July 2006

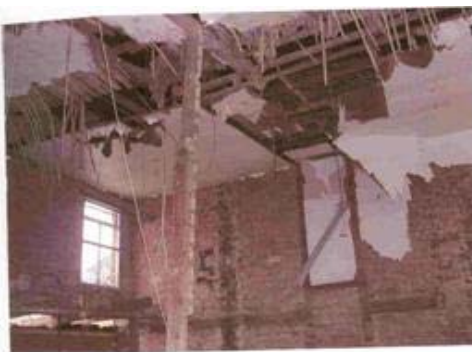
A 'prop' spliced together from old floor joists

A reporter was called to give a second opinion to a Building Control Authority which had made a visit to a site to find that the whole of the internals of a two storey building had been completely removed. This was a building which had been a row of 3 or 4 shops in a longer terrace and all cross walls and the first floor had been removed. The front wall was approximately 18m long with no returns. The roof trusses, 6m above the ground floor, had been left supported on props made by nailing floor joists together; one at each party wall position. There was possible evidence of wall plate movement on the front elevation. The building was liable to collapse and the road at the front was closed until the structure could be stabilised.

Several photographs were enclosed and a sample is shown on the left of one of the 'props' spliced together from old floor joists.

Comment This is one of several reports on dangerous temporary works during conversions of existing brick built buildings. It seems that whilst the designs for the final schemes are satisfactory and have Building Regulation approval, the contractors who have been involved have either not followed the designer's intentions, or have not had their own method statement, or have simply not appreciated the possible consequences of inadequate temporary works. Indeed HSE regards amateur house alterations as a significant area of risk and injury. In such cases if the structure is deemed to be dangerous a Local Authority can use its powers under the Building Act to make the property safe. Provisions that should have applied to the designers are the CDM Regulations, whilst the builders should have followed the CDM and CHSW Regulations. (Report DI 046)

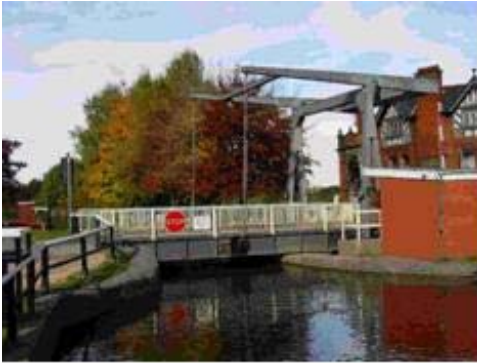
Bridge before failure

The lift bridge is of the Dutch style with an overhead counterweighted frame. It carries Plank Lane, an unclassified road, over the Leigh Branch of the Leeds – Liverpool Canal. The failed component was the connection between the counterweight and one of the longitudinal arms of the overhead frame. This was a bolted connection with eight bolts passing through the arms of the frame into threaded holes in each endplate of the counterweight. Only the bolt heads were visible and it was not possible to ascertain the bolt condition through normal inspection procedures.

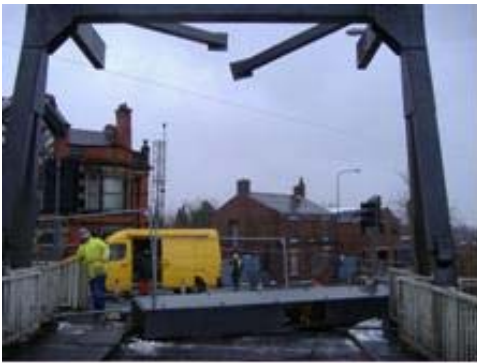
After failure with counterweight across carriageway

A component failure on a British Waterways' lift bridge has resulted in a 22 tonne counterweight falling some 5.0m onto a public highway. The road was not open to traffic at the time and there were no injuries. The incident was, nevertheless, serious and was followed by the closure of all British Waterways lift bridges of similar type until they were checked by Engineers and the risk of similar occurrences either ruled out or removed.

One of the principal connections failed as the bridge deck was going through its normal closing cycle. Initial investigations indicate that the bolts in this connection yielded in shear. The actual cause of the failure is yet to be confirmed but sequential shear failure due to uneven distribution of load between bolts, fatigue due to cyclic loading and even accidental or dynamic impact loading are all possibilities.

Once this connection gave up the other principal connection followed suit in a twisting manner with a number of its bolts yielding in tension. The secondary cross bracing connections failed at the same time and the counterweight fell to the ground.

British Waterways' subsequent actions were to close all of its structures of a similar type and check them for hidden and inaccessible connections. Where these were found further investigations followed to ascertain the condition of the connections. In a couple of cases, where connections could not be immediately exposed, the bridges were kept out of service or alternative supports provided until the condition of the structures was assured. A full review of the maintenance and inspection regime for these structures will be undertaken in due course.
