# Development of CROSS - Confidential Reporting on Structural Safety

**Alastair Soane**, Director of CROSS, London, UK

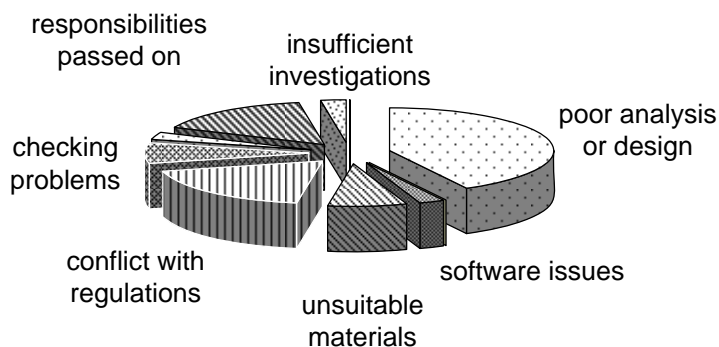
Figure 1 Design concerns

The greatest number of reports has been about the poor quality of Building Regulations submissions including concerns about inadequate calculations, sometimes from non-engineers but also from larger firms and component suppliers. Particular attention has been drawn to poor submissions for minor works and alterations to existing buildings. There are also reports about specific categories of building where the quality of design is not satisfactory. Major categories are shown in Figure 1.

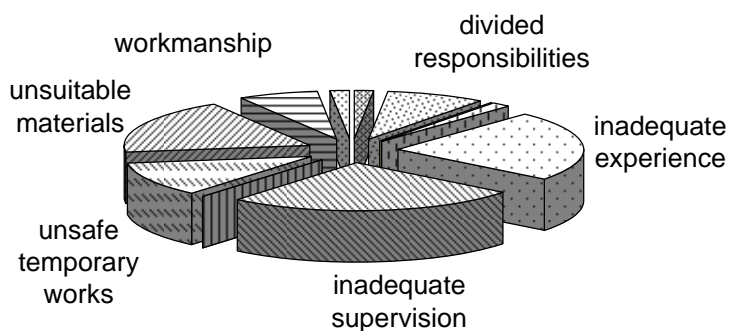
Figure 2 Construction concerns

before concreting to collapses of partially built structures. Steelwork deficiencies have also been reported such as wrong materials delivered to site, erection failures, and near misses. Figure 2 gives the main categories for concern about the construction process.

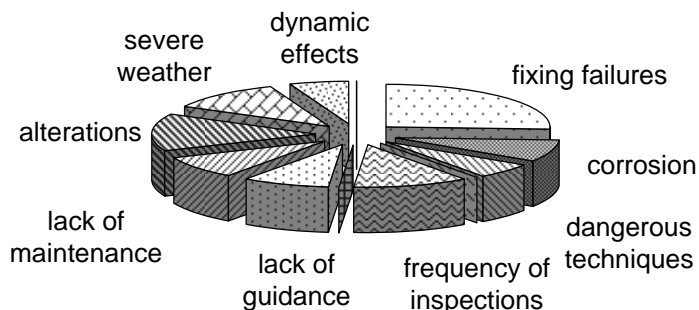
Figure 3 Operational concerns

had a 22 tonne concrete counterweight suspended over a roadway. Fixings, which could not be inspected, corroded over time and the counterweight fell. There could easily have been a car underneath. A church built as a composite masonry structure has granite cladding on the front façade and steel joists as lintols behind the door and window openings. The steel corroded over the years and the resulting expansion pushed off large pieces of granite which fell without warning. Figure 3 shows the major categories of concern about operational matters.
